Office of the Auditor
General of Norway

The Office of the Auditor General's investigation of the authorities' work on the Alexander L. Kielland accident

Document 3:6 (2020–2021)

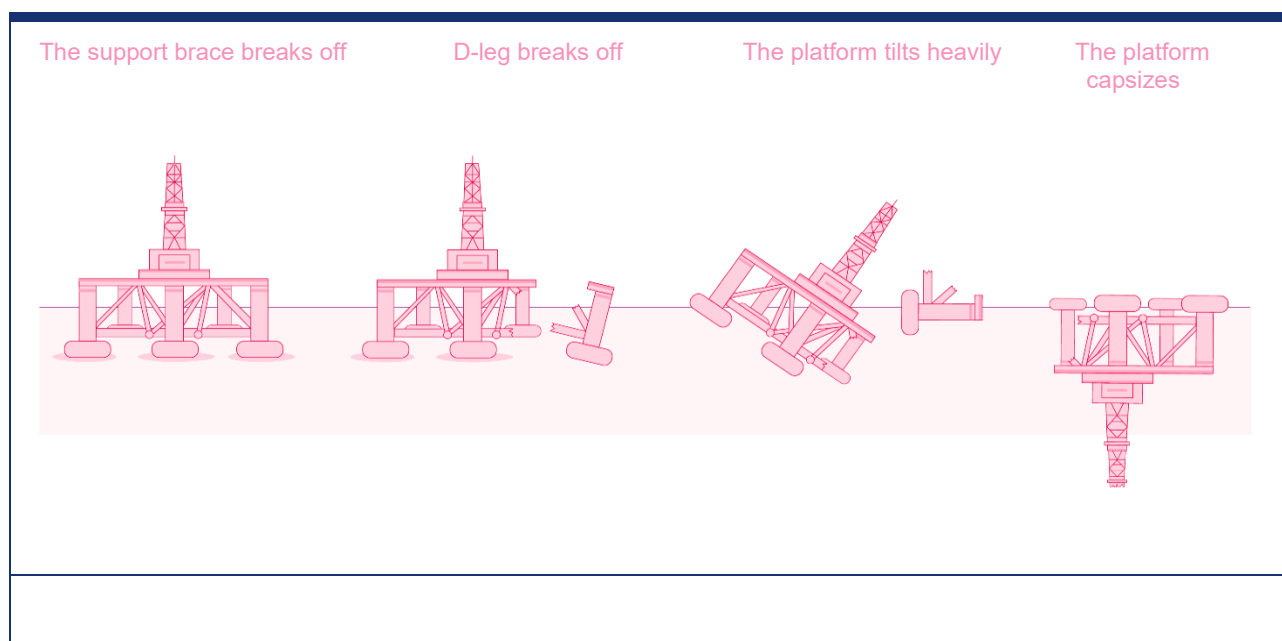
Figure 1 Illustration of the sequence of events

Alexander L. Kielland was a semi-submersible drilling platform used as a flotel on the Ekofisk field in the North Sea. On 27 March 1980, the platform lost one of its five legs in rough sea and the platform capsized within 20 minutes. The sequence of events is illustrated in figure 1. The final death toll was 123 fatalities and 89 survivors. The accident is considered the worst in Norwegian industrial history. The Government set up a commission of inquiry the day after the accident. The police also investigated the accident and the commission of inquiry and the police cooperated on gathering information. The Commission's report was published in March 1981 (NOU 1981: 11).

The Commission concluded that the accident was due to a fatigue crack in a brace supporting one of the platform's legs. According to the Commission, the fatigue crack was caused by an error during the planning and construction of the platform. To recover more victims and gain more information about the causes of the accident, the platform was righted in 1983. The Commission then carried out new investigations and submitted an additional report. Later that year, the platform was sunk in Nedstrandsfjorden.

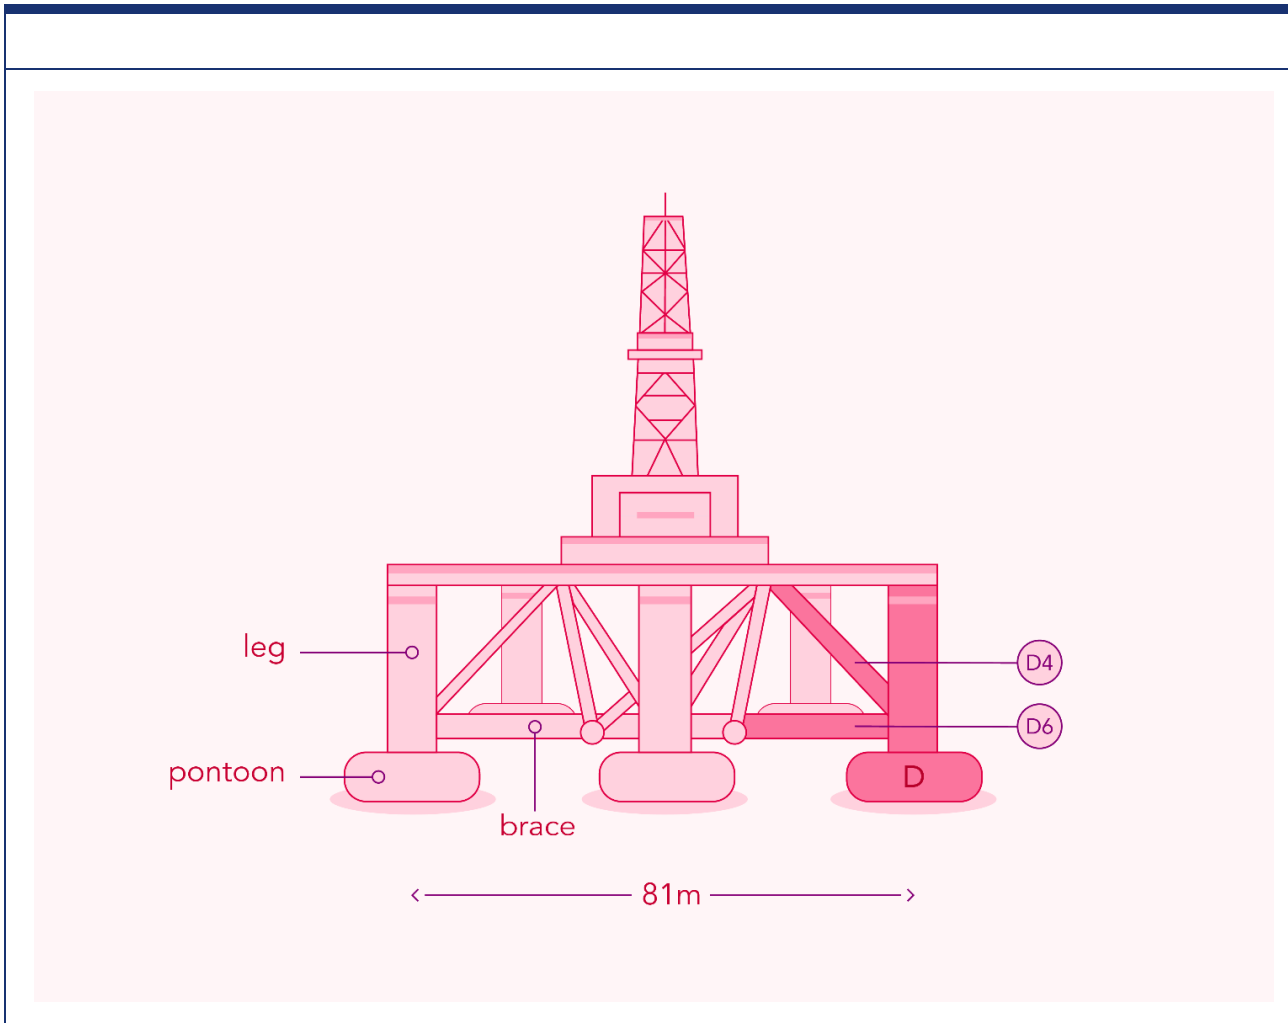
Figure 2 Illustration a Pentagone platform with legs and braces

In other words, the Commission concluded that the triggering cause of the accident was a fatigue crack in one of the braces on the platform, more specifically brace D6 (see Figure 2). A fatigue crack had developed where a support for a hydrophone was welded to the brace, and the crack grew into a fracture. The investigation shows that the Commission conducted thorough technical investigations to clarify the causes of the fracture.

The Norwegian Commission concluded that the fatigue crack developed due to an error that was made during the planning and construction of the platform. The combination of poorly executed welding, the use of low-quality steel and inappropriate method for attaching the hydrophone holder led to fatigue cracks developing in the brace. The cracks in the weld between the hydrophone holder and the brace constituted a

weak point where fatigue cracks developed and extended to the brace. These cracks continued to grow into a fracture. The Commission found paint residue in the cracks in the weld and concluded that the cracks had occurred during the construction of the platform.
